**G.3 Approve Change Order Summary Report – July 2025**

**CHANGE ORDER SUMMARY #57**

RE Chippewa Valley Schools  
Bid Pack 7 – Clinton Valley Elementary Northwest Parking Lot –  
Furnish and install geogrid subgrade.

DATE July 9, 2025  
TO Scott Sederlund, Chippewa Valley Schools  
FROM Cris Tollis, Barton Malow Builders  
RE Chippewa Valley Schools  
Bid Pack 7 - Dakota High School North Parking Lot

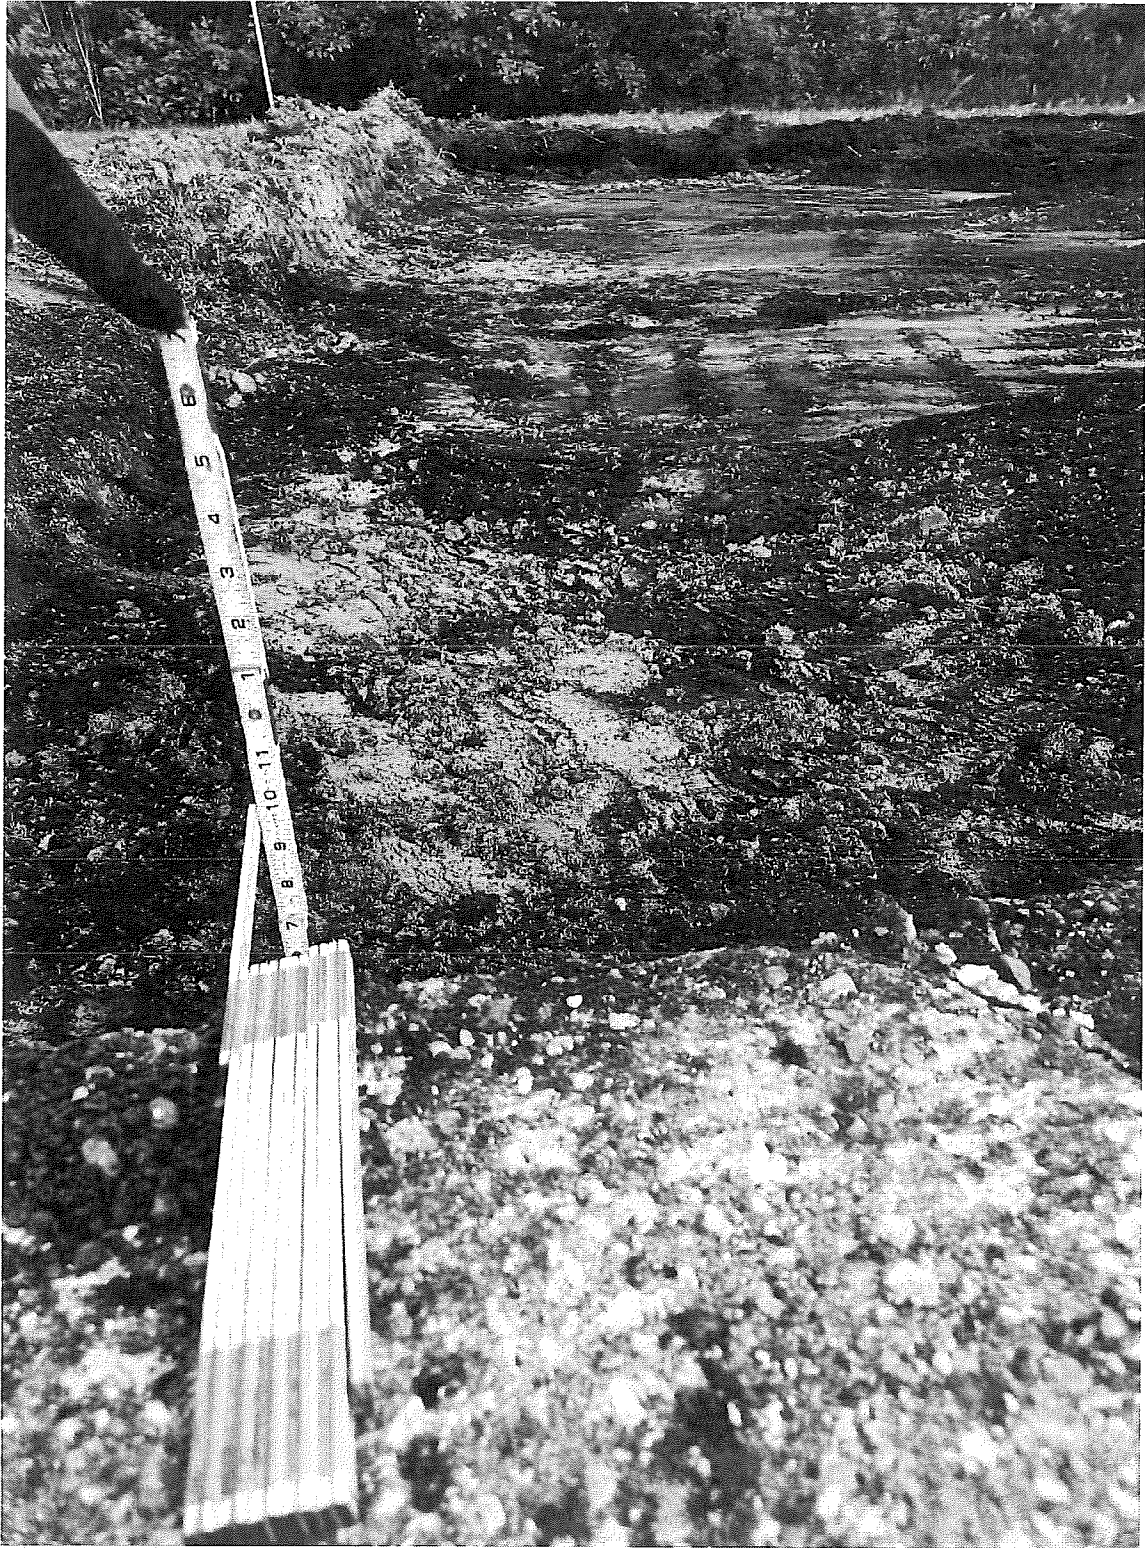
A G2 Inspector was on site during testing and noticed unsuitable soils. In lieu of undercutting, which would be more costly based solely on the volume of stone removed and stone replaced, T&M provided a geogrid subgrade. Additional stone was also required to bring the base of the new lot to the existing heights. The asphalt removed was thicker than expected (see attached photo), thus the need for additional stone backfill. This additional work will be funded from the bond program contingency budget.

Clinton Valley Elementary  
Northwest parking lot - existing paving cross section

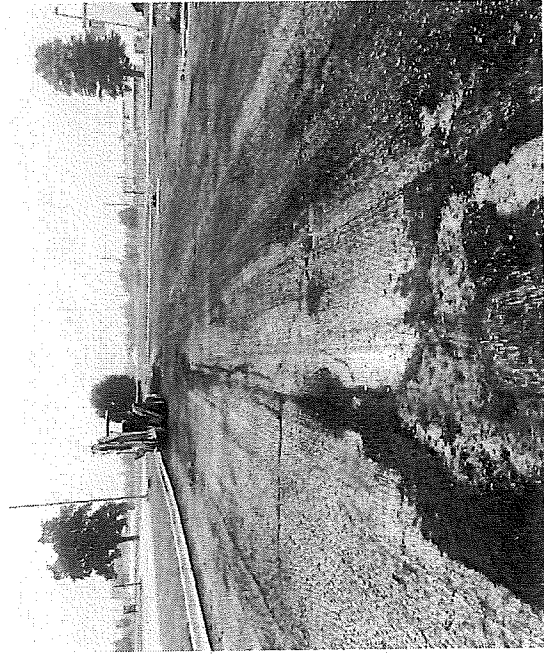
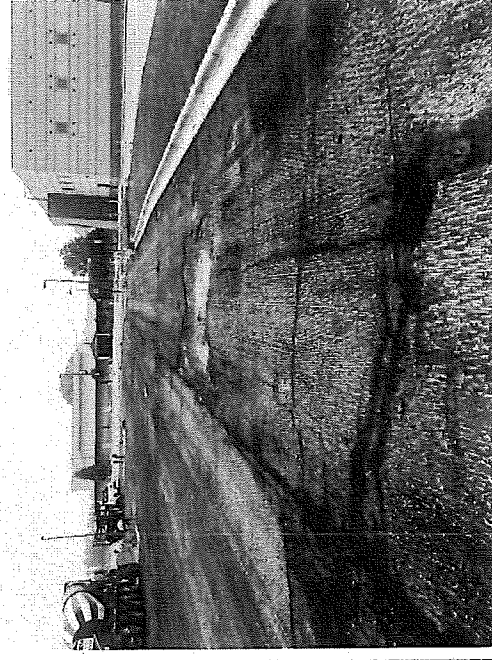
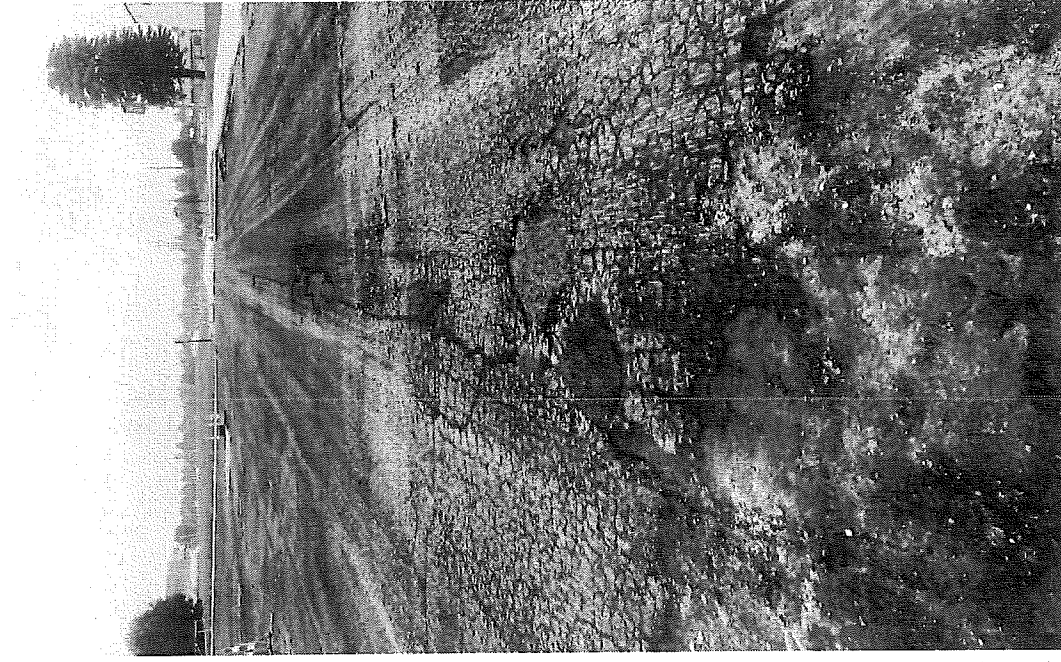
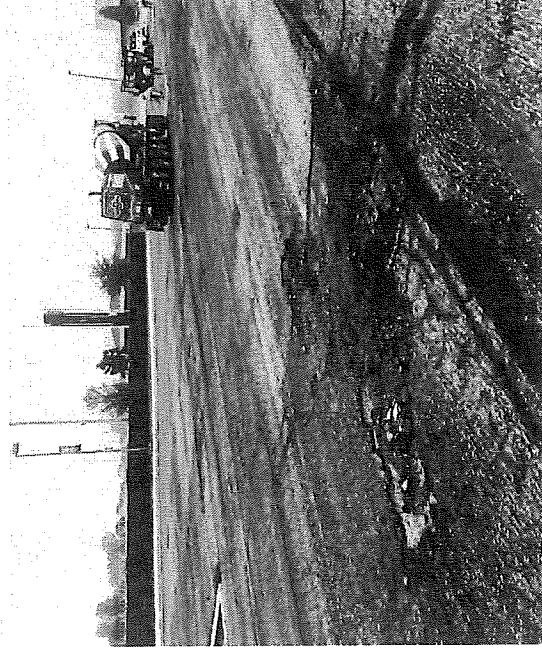
The original scope of work involved milling and resurfacing the majority of the existing pavement. A marked-up drawing from the bid documents is included following this memo. However, during the milling operation, it was determined that the underlying base course was in poor condition. See attached photos and field report from the independent testing agency (G2). In response, several corrective options were evaluated—please refer to the attached analysis and summary, which outlines both cost implications and anticipated service life extensions.

The images show areas where the milling operation has exposed a severely compromised base course, marked by cracking, voids, and material loss. These conditions confirm that the underlying structure lacks adequate support and will require significant repair or replacement to meet performance standards.

Based on this evaluation, the project team selected the full replacement option with targeted subgrade undercuts. This approach was determined to provide the most durable long-term solution while balancing cost and performance expectations.

Barton Malow has reviewed the contractor's proposal to remediate the failed subgrade in accordance with specifications provided by G2 and the project architect. All aspects of the proposal were found to align with current unit pricing and expected value benchmarks.
